# Site Assessment and Closure Plan

## Adams County Shooting Range

November 10, 2016

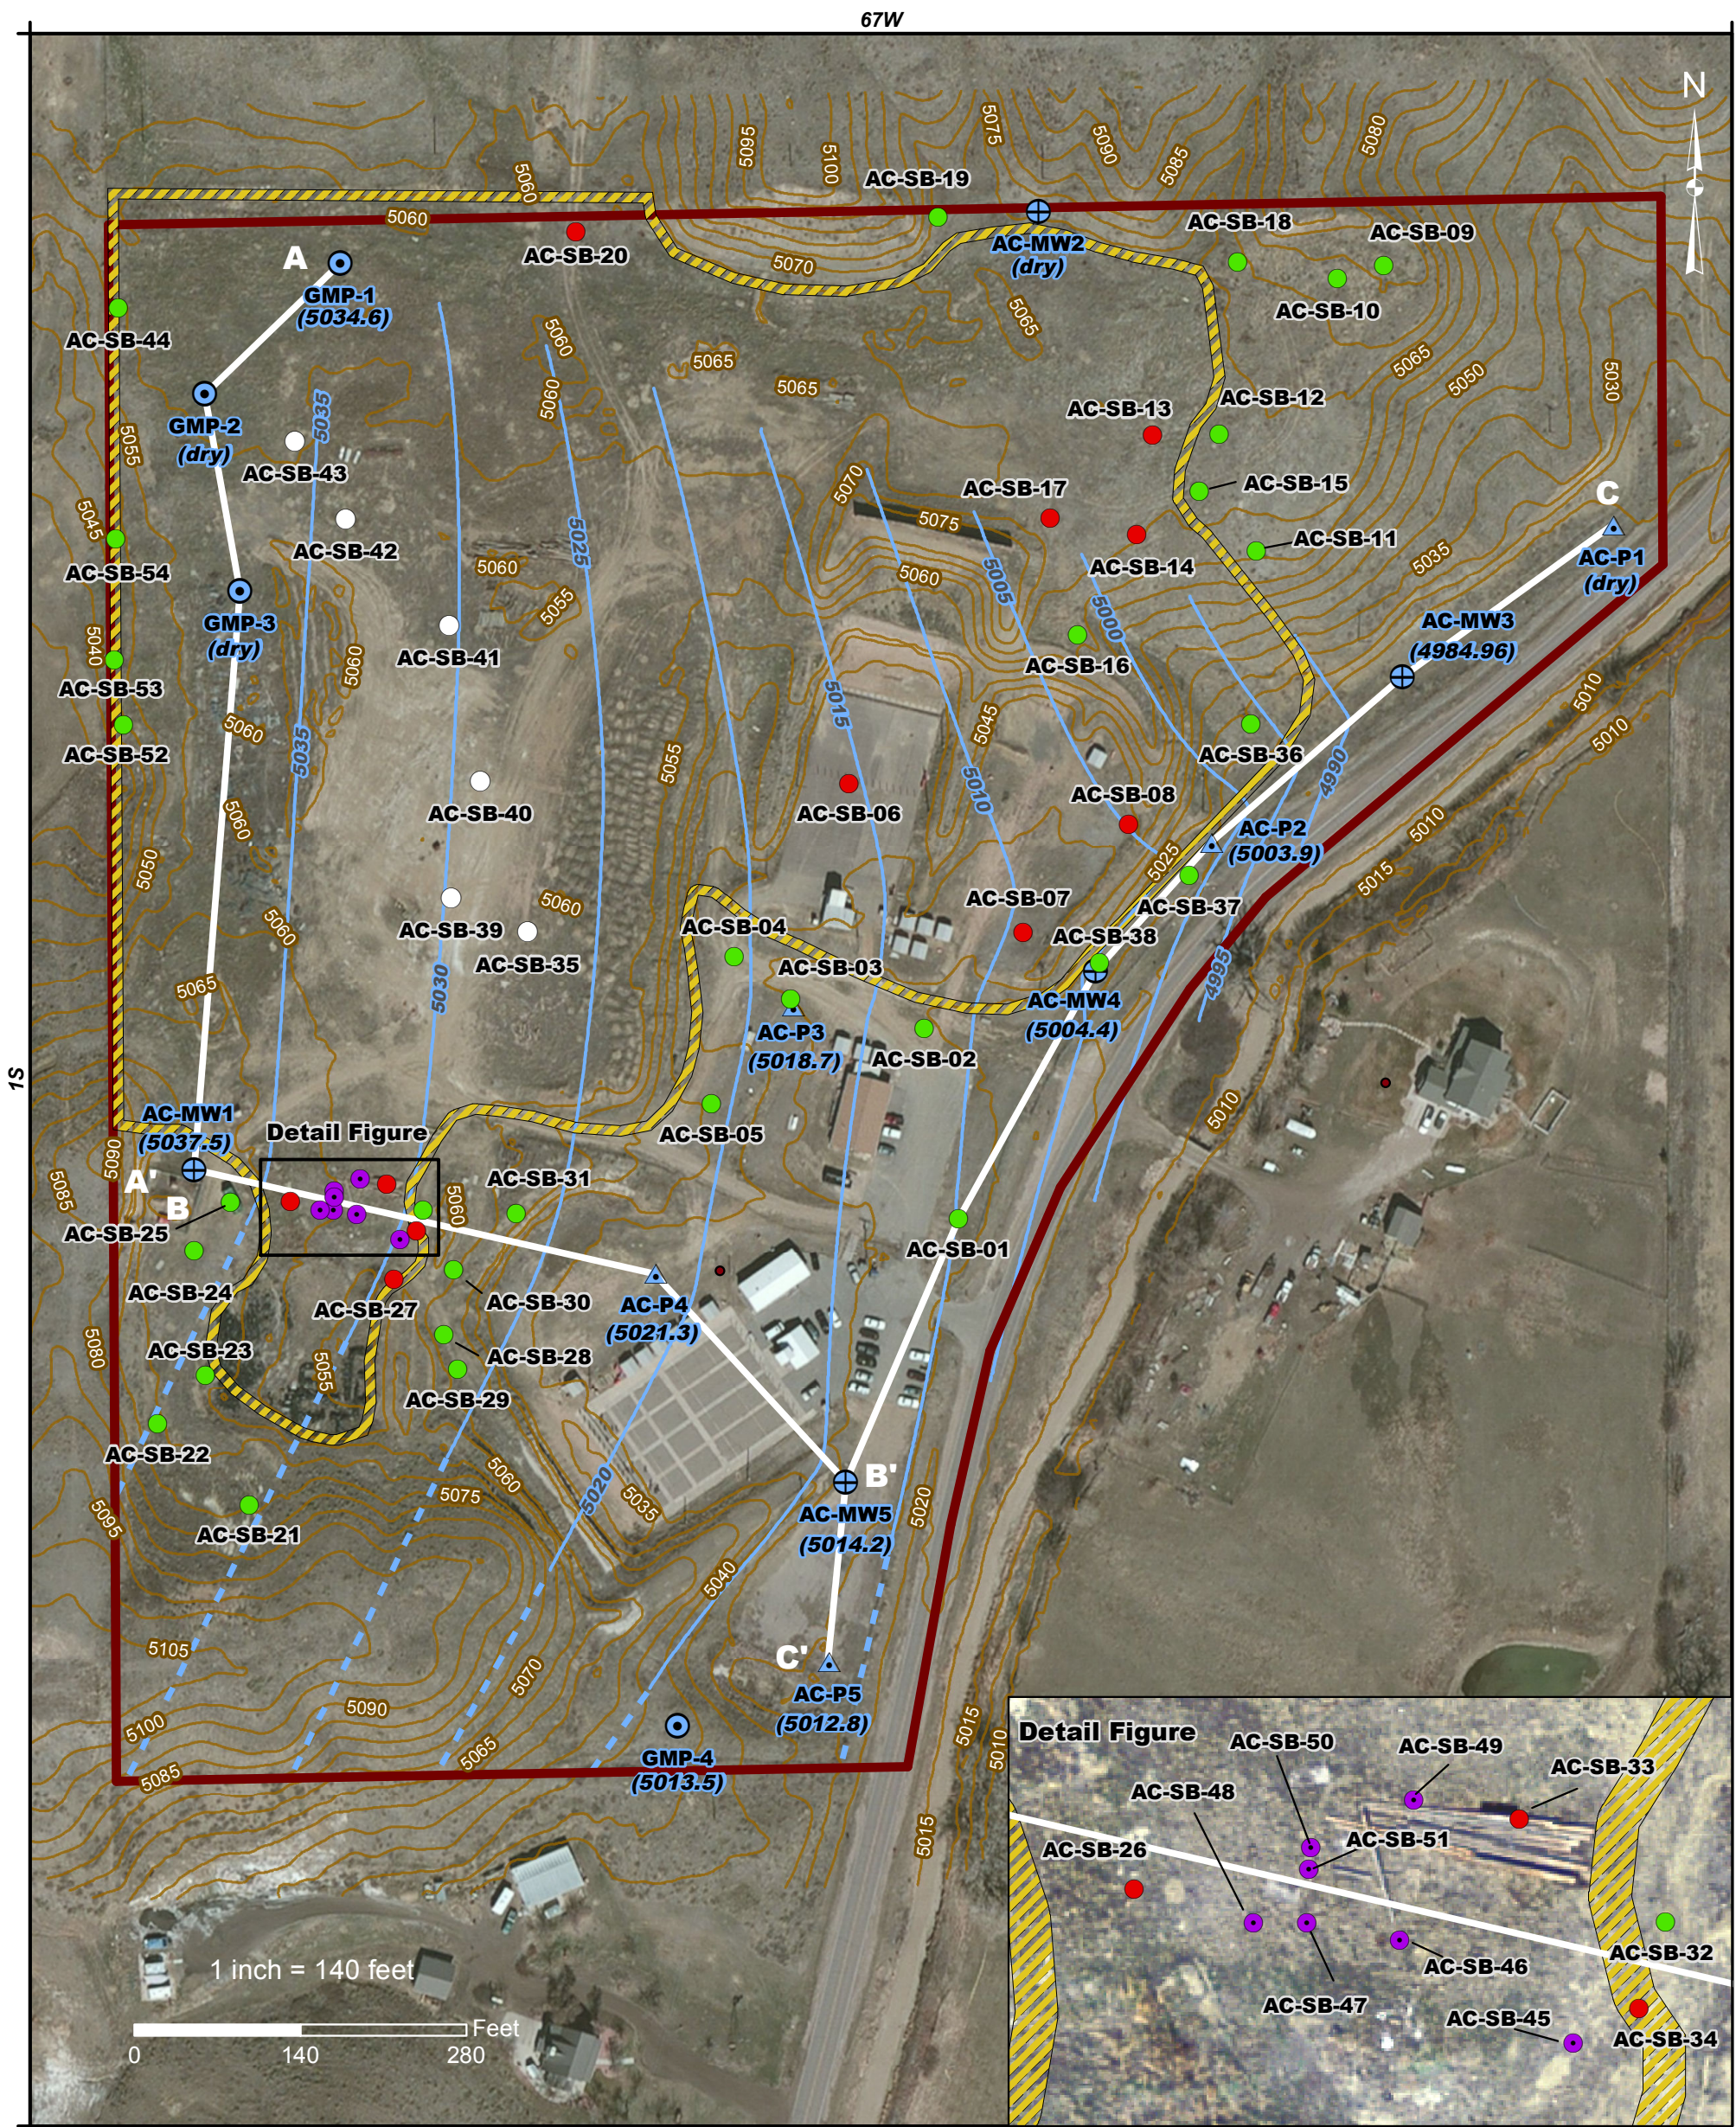
Figure 3: Cross-Section Plan View

Figure 3 illustrates the location of three cross-section lines that were created through the Site. Figures 3A through 3C are the cross-sections; two north-south and one east-west. These cross-sections illustrate the location of the subsurface materials in relation to the depth to groundwater. As depicted on the north-south cross section A-A' (Figure 3A) there is a separation of approximately 10 feet between the waste material and the groundwater. Groundwater was not observed in any boring, monitoring well or piezometer that penetrated the waste material.

Quantum's field geologist observed and documented the soils encountered in the borings for type, color, grain size, and other soil characteristics using the USCS. Soil cores were observed for indications of impact, namely visible staining or foreign material in the soil. Soil samples were collected for field screening purposes and placed into labeled, plastic, sealable bags for headspace screening using a PID. PID field screening did not detect the presence of VOCs in any of the boreholes. Piezometer and monitoring well locations are shown on Figure 3.

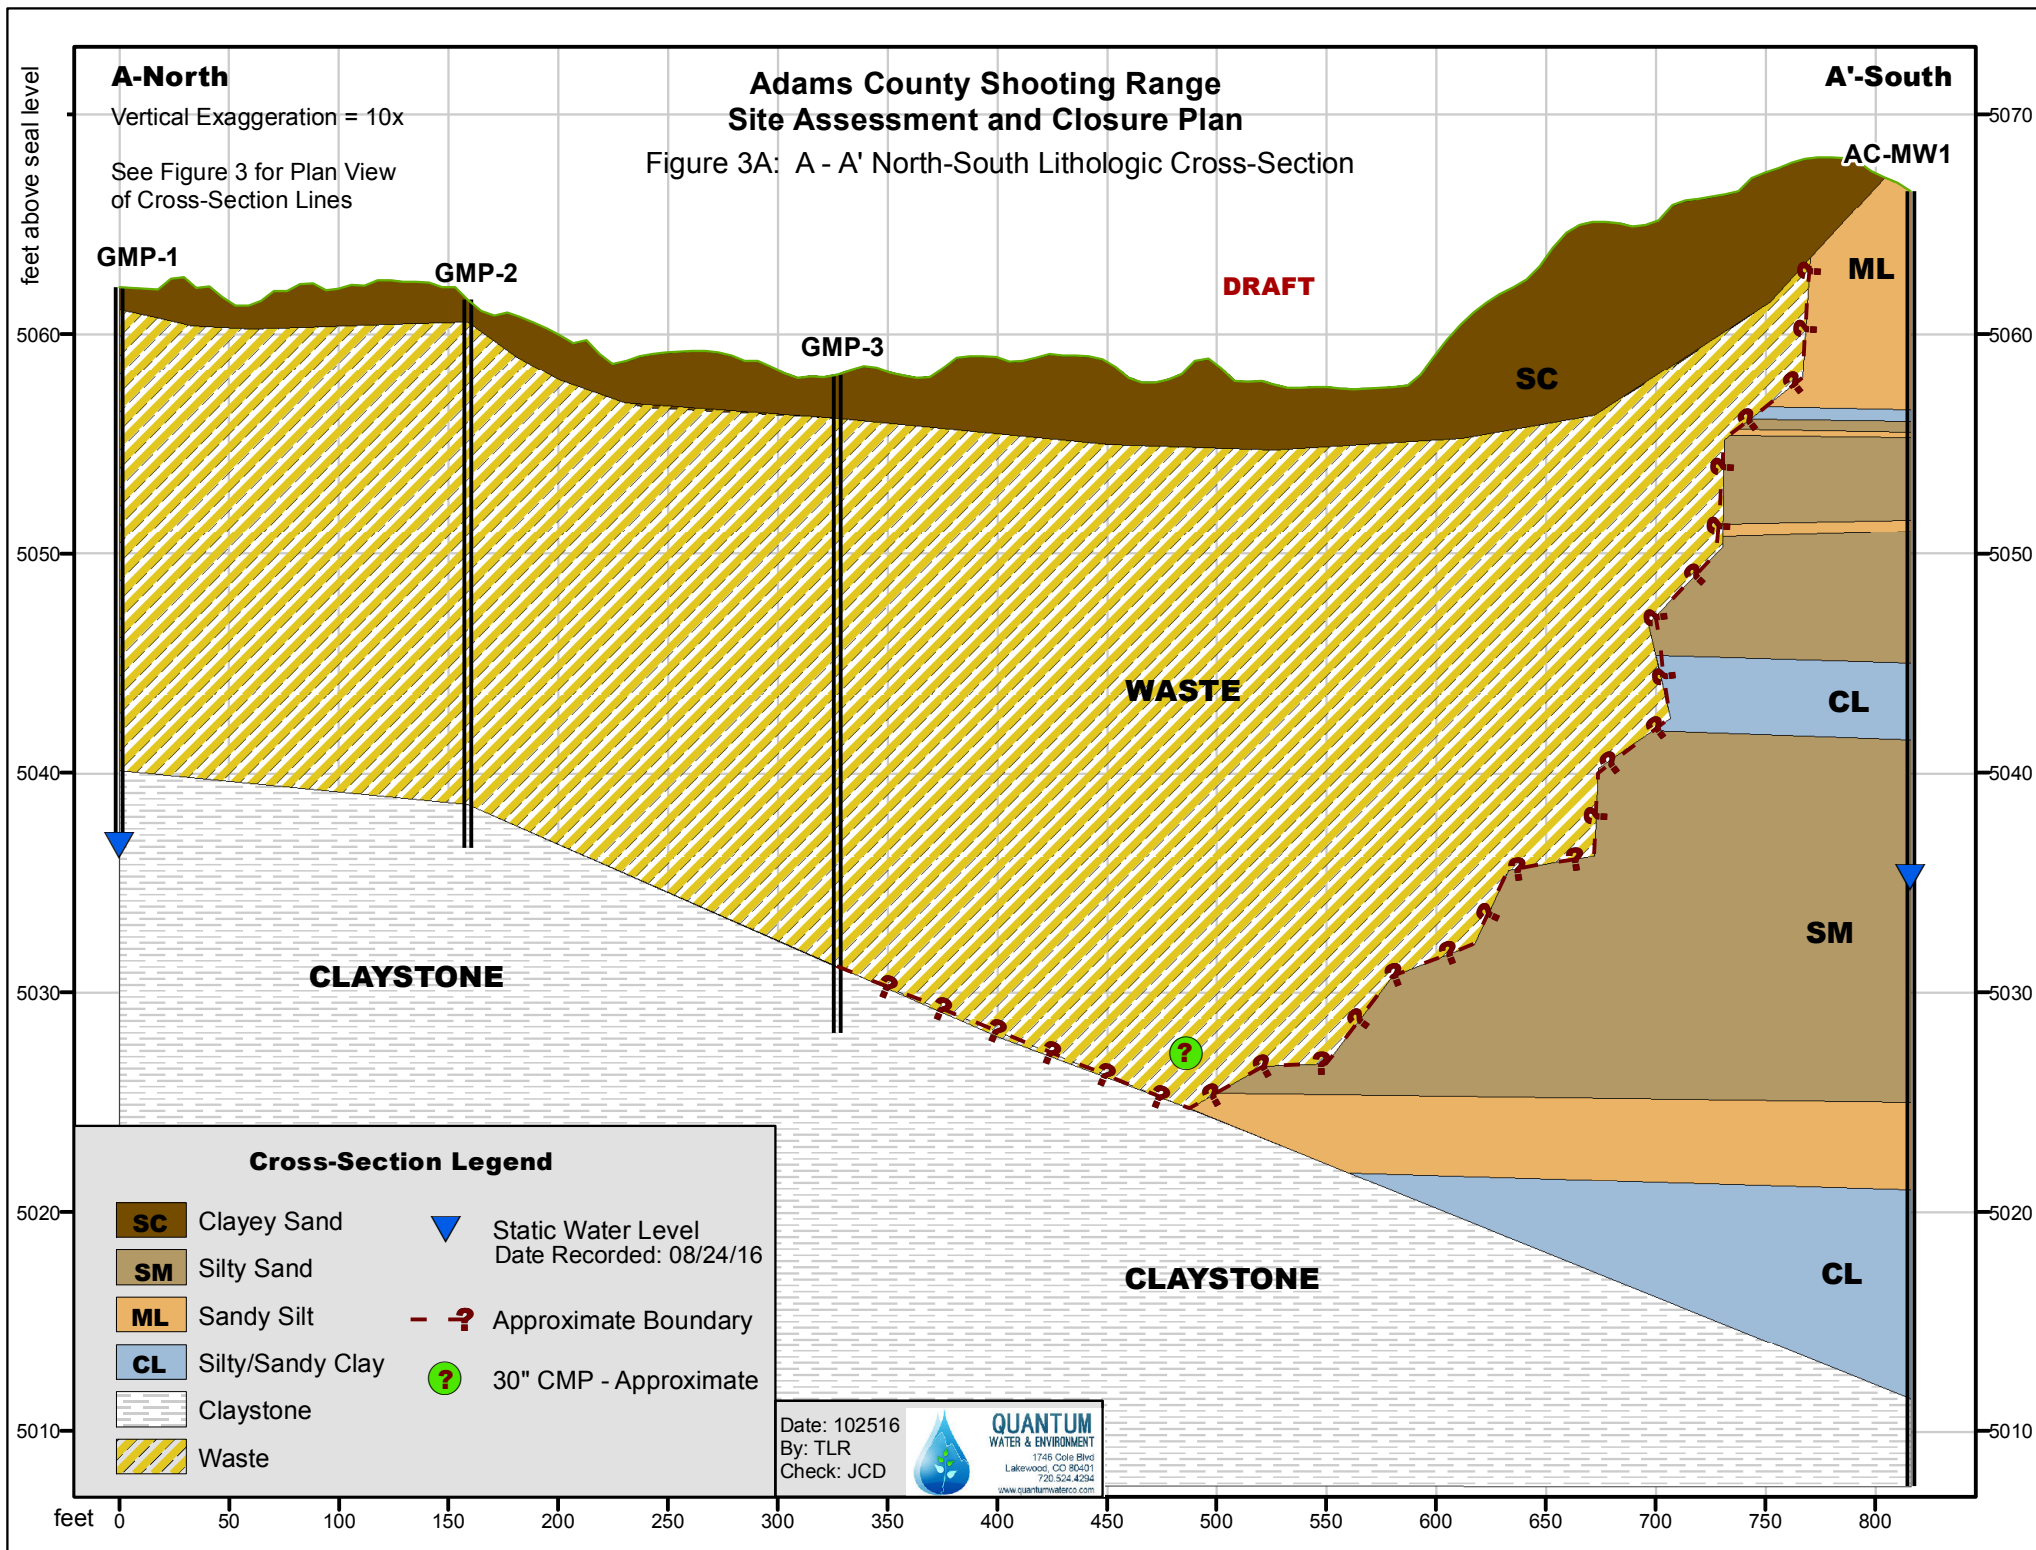
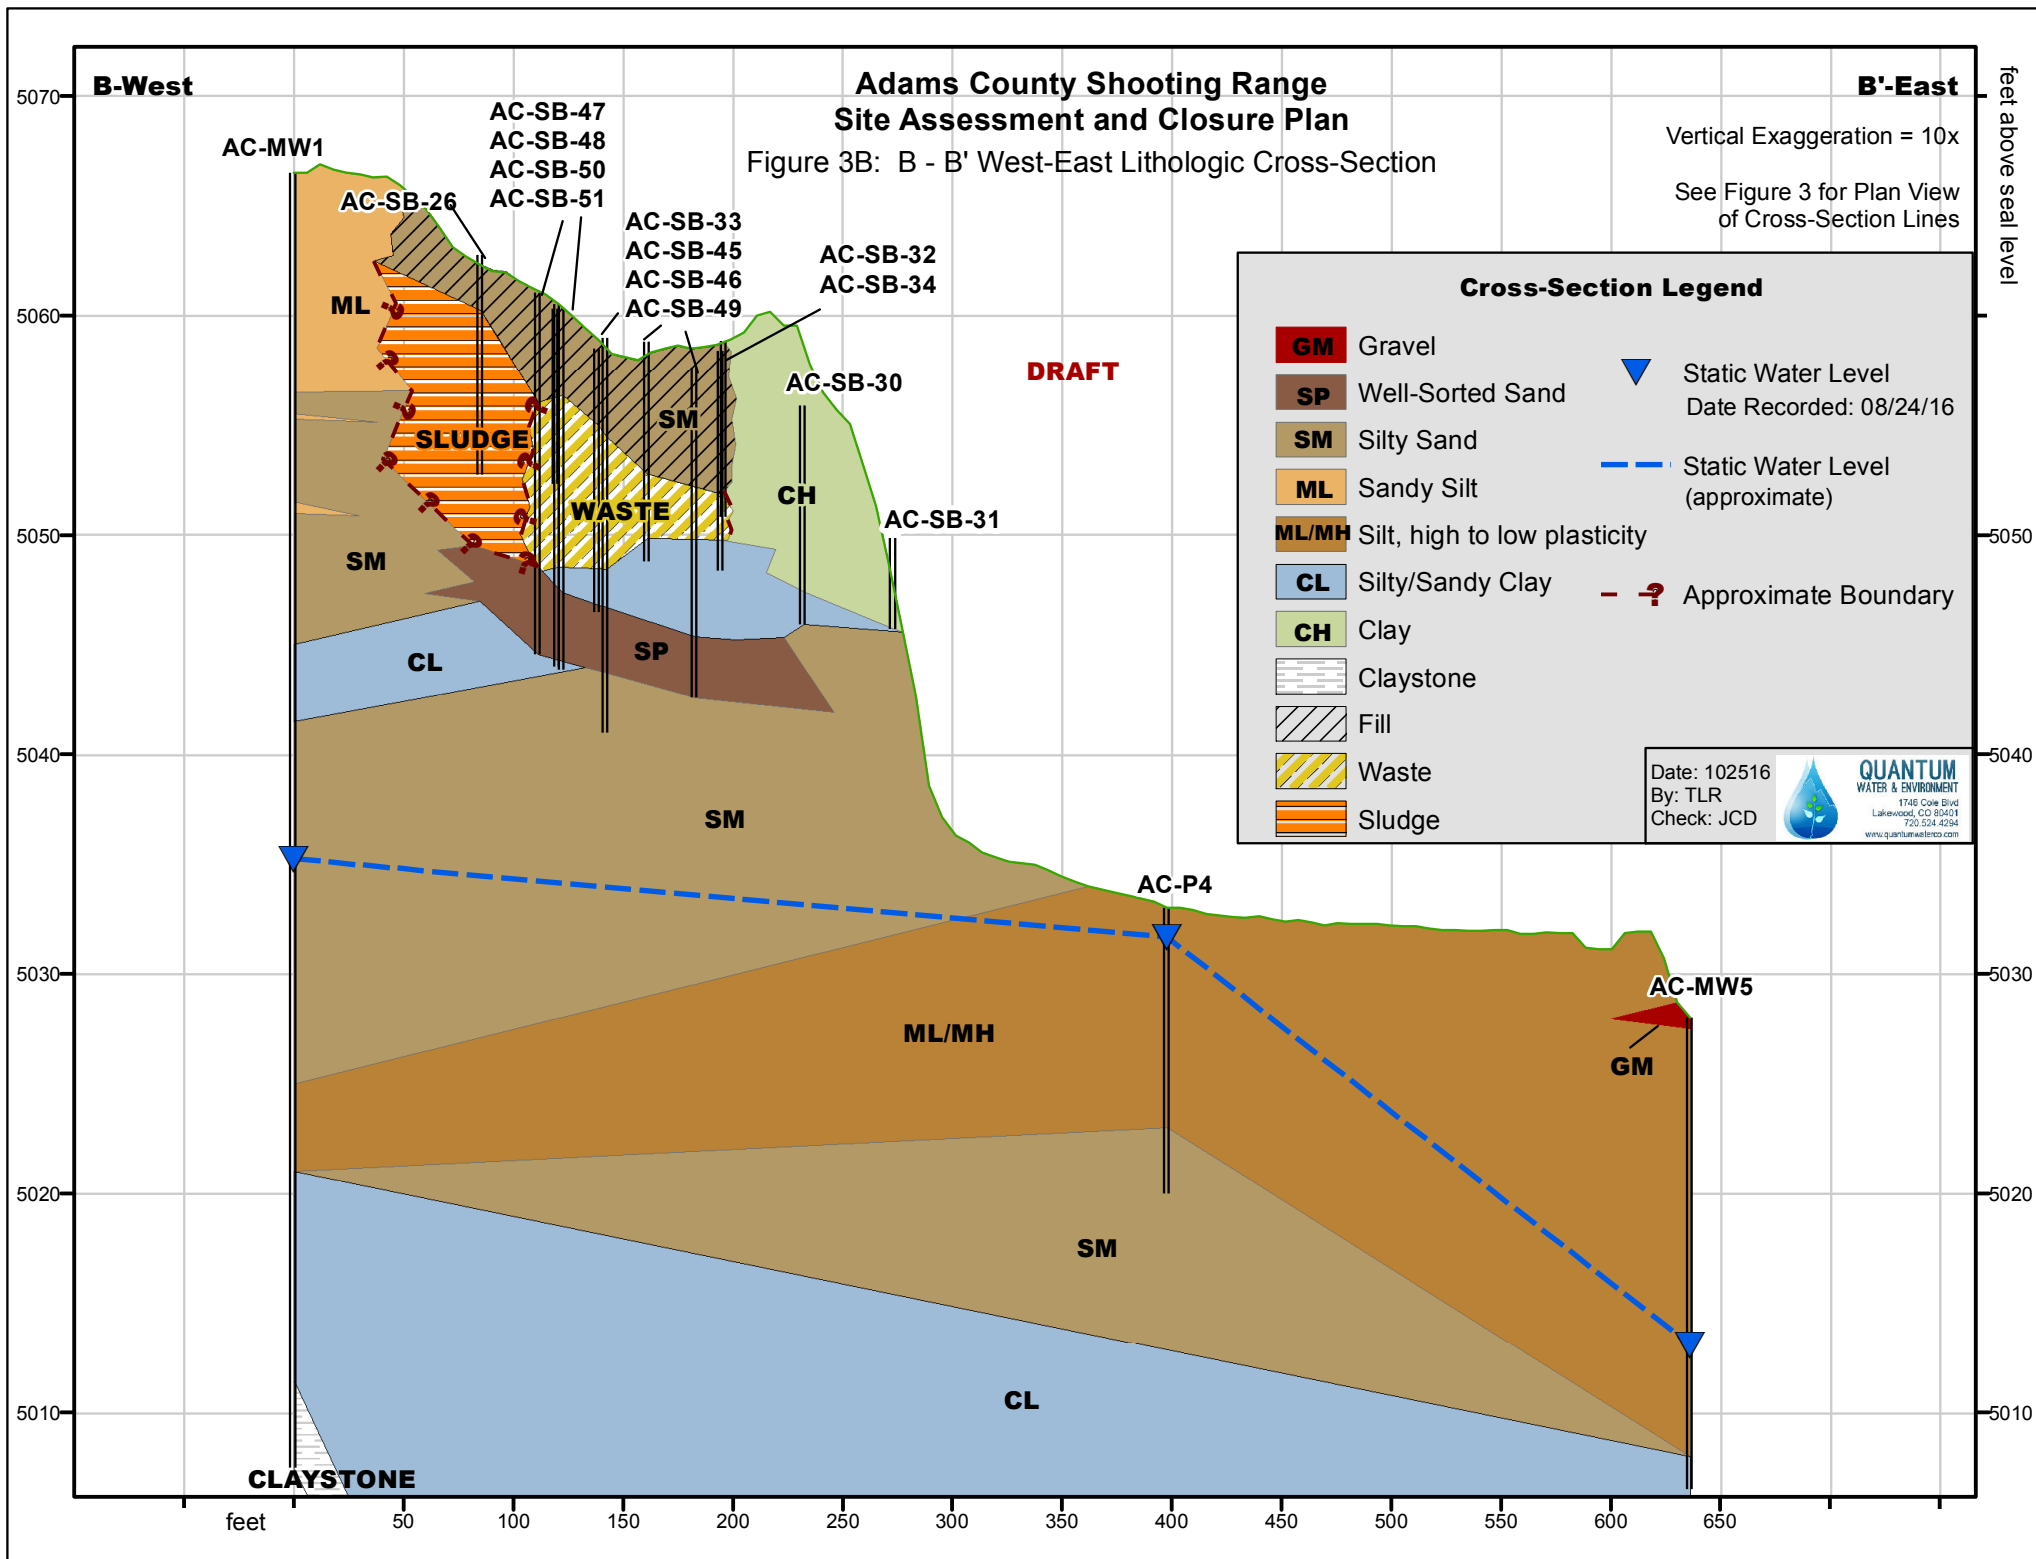
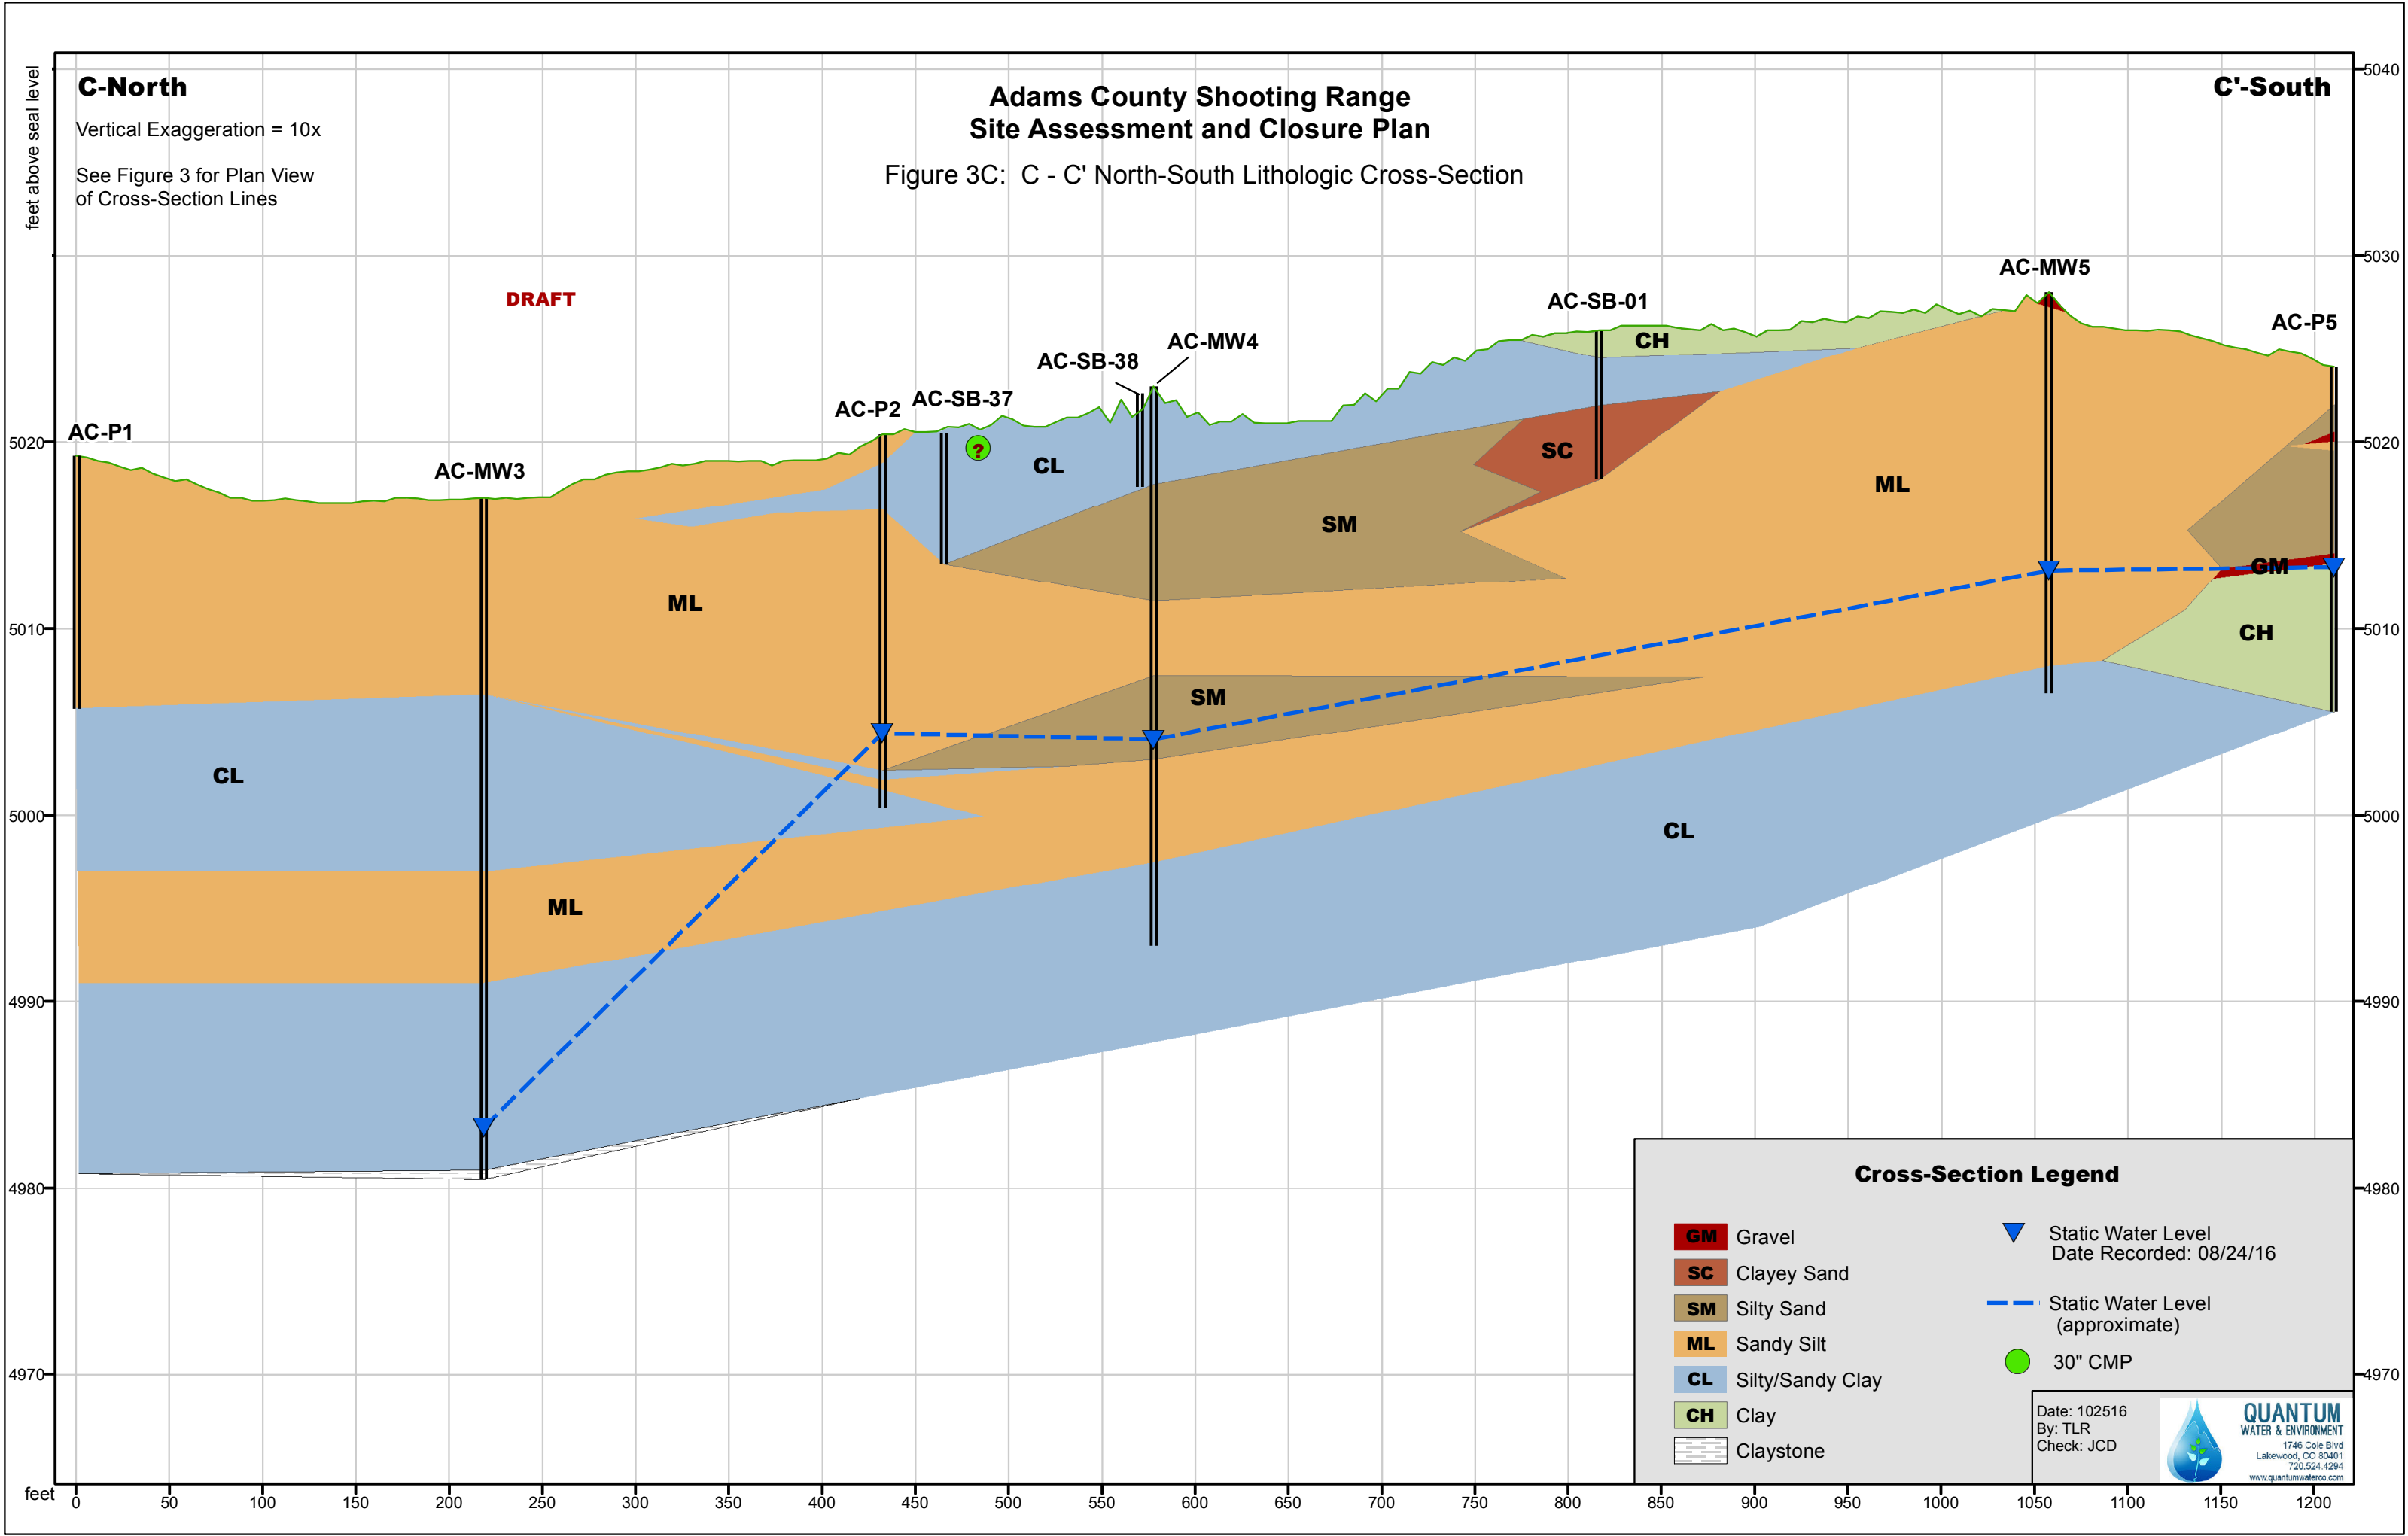
Layers of clay, silty sandy clay, sandy silt and well sorted sand were found throughout the Site. A lense of gravel was located at the southern end of the site as illustrated on Figures 3B and 3C. Silty sand fill material was found above the waste and is depicted on Figure 3B. Beneath the waste material a silty sandy clay and a well sorted sand exist at approximately 4 to 5 ft and beneath those materials is a silty sand (Figure 3B).

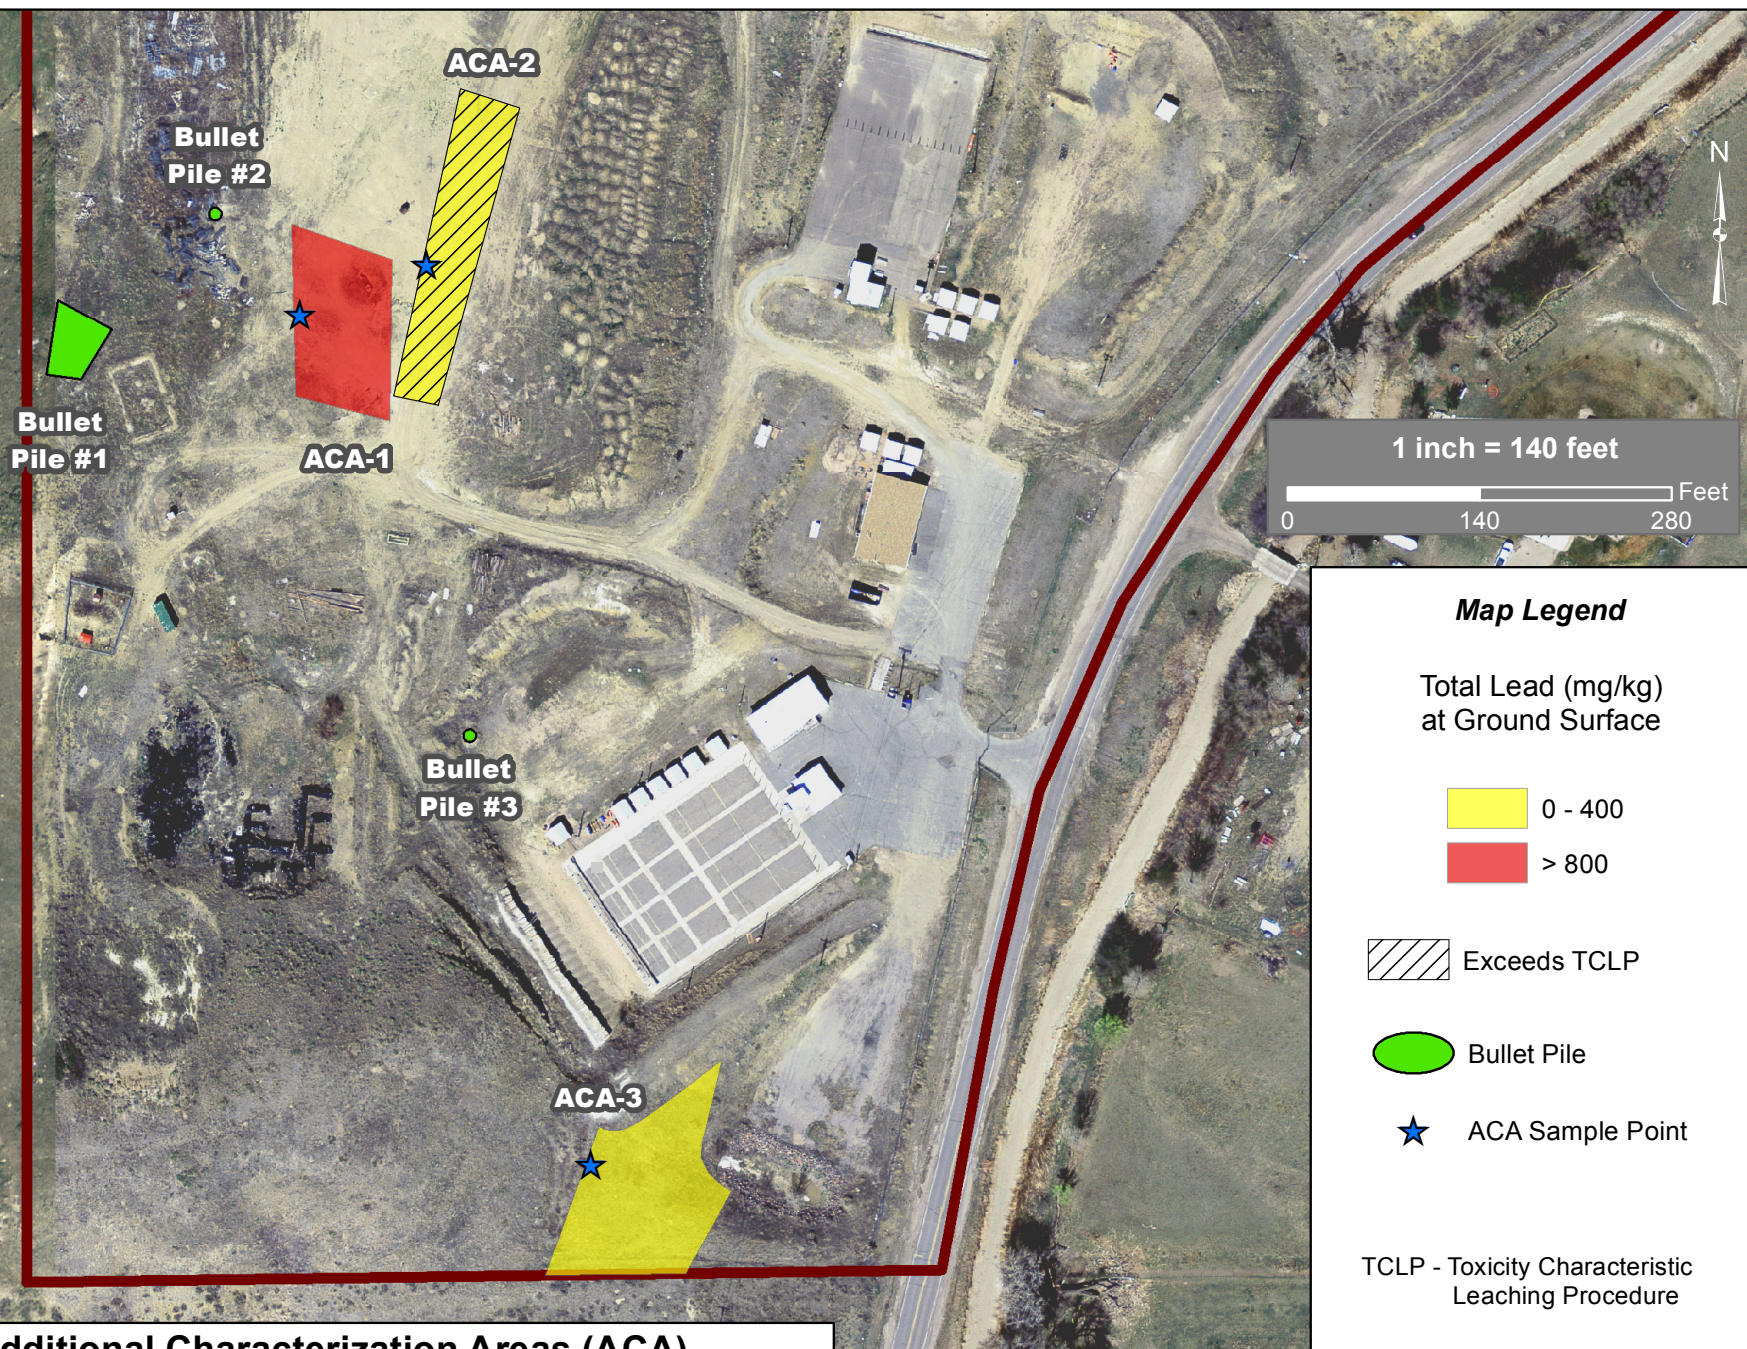
**Figure 6A: Additional Characterization Areas (ACA)  
Sample Total Lead and TCLP Summary at Ground  
Surface and Bullet Pile Areas**

**Waste Ammunition Disposal Areas:** During site walks, several piles of bullet fragments intermixed with soil were observed outside of shooting range areas on top of the landfill area. The observed piles were approximately one cubic yard or less in size and contained a significant amount of waste bullet fragments.
