Appendix J - Notices of Intent

Appendix K - Soil Geotechnical Reports

Appendix N - Land Survey Reports

Lead-Based Paint Inspection and XRF Testing Report

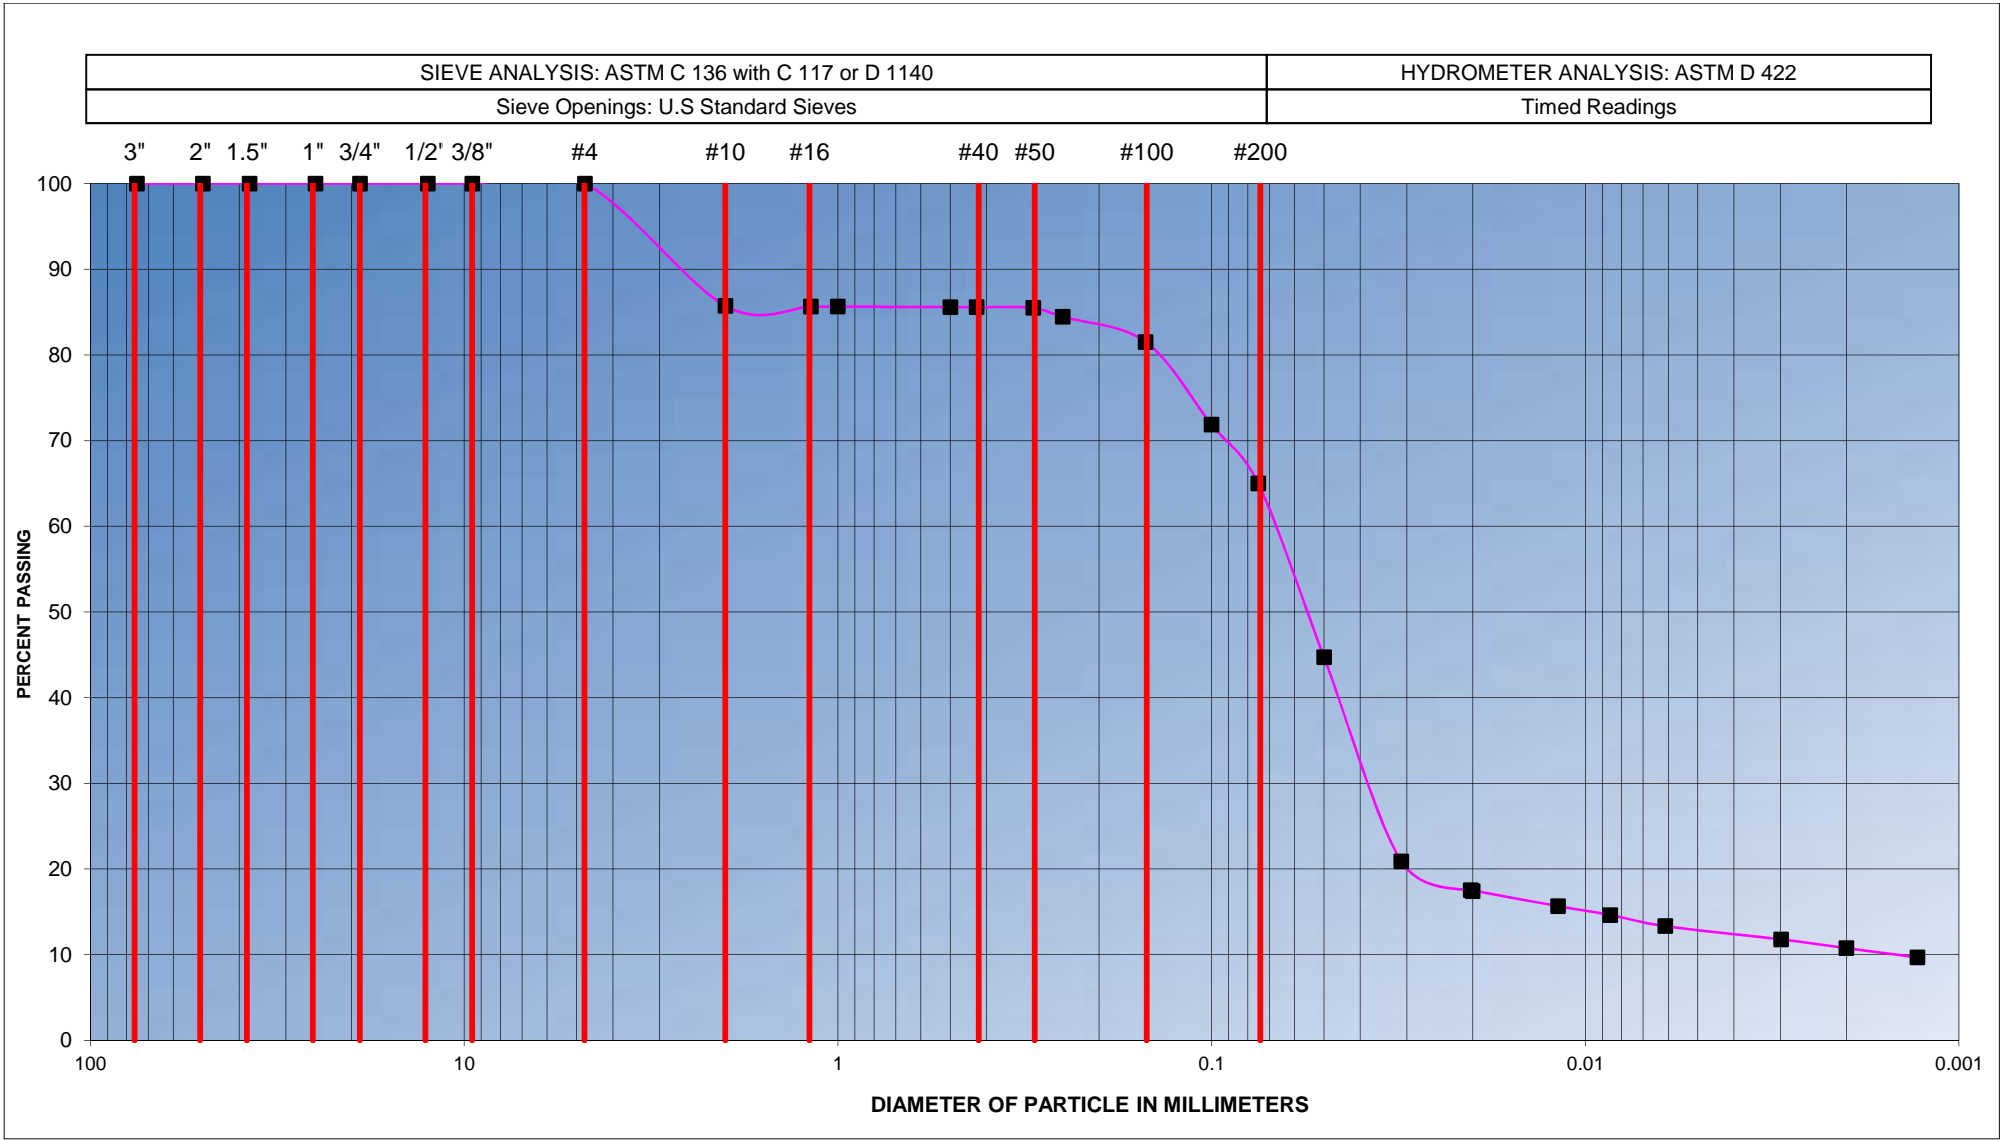
Gravel	0%	Sand	35%	Silt and Clay	65%	<div>GROUNDENGINEERING CONSULTANTS</div>
From: AC-SB-21, 11:20 8/24/2016						GRADATION TEST RESULTS	
						JOB NO.: 16-1163	
						FIGURE: 3984

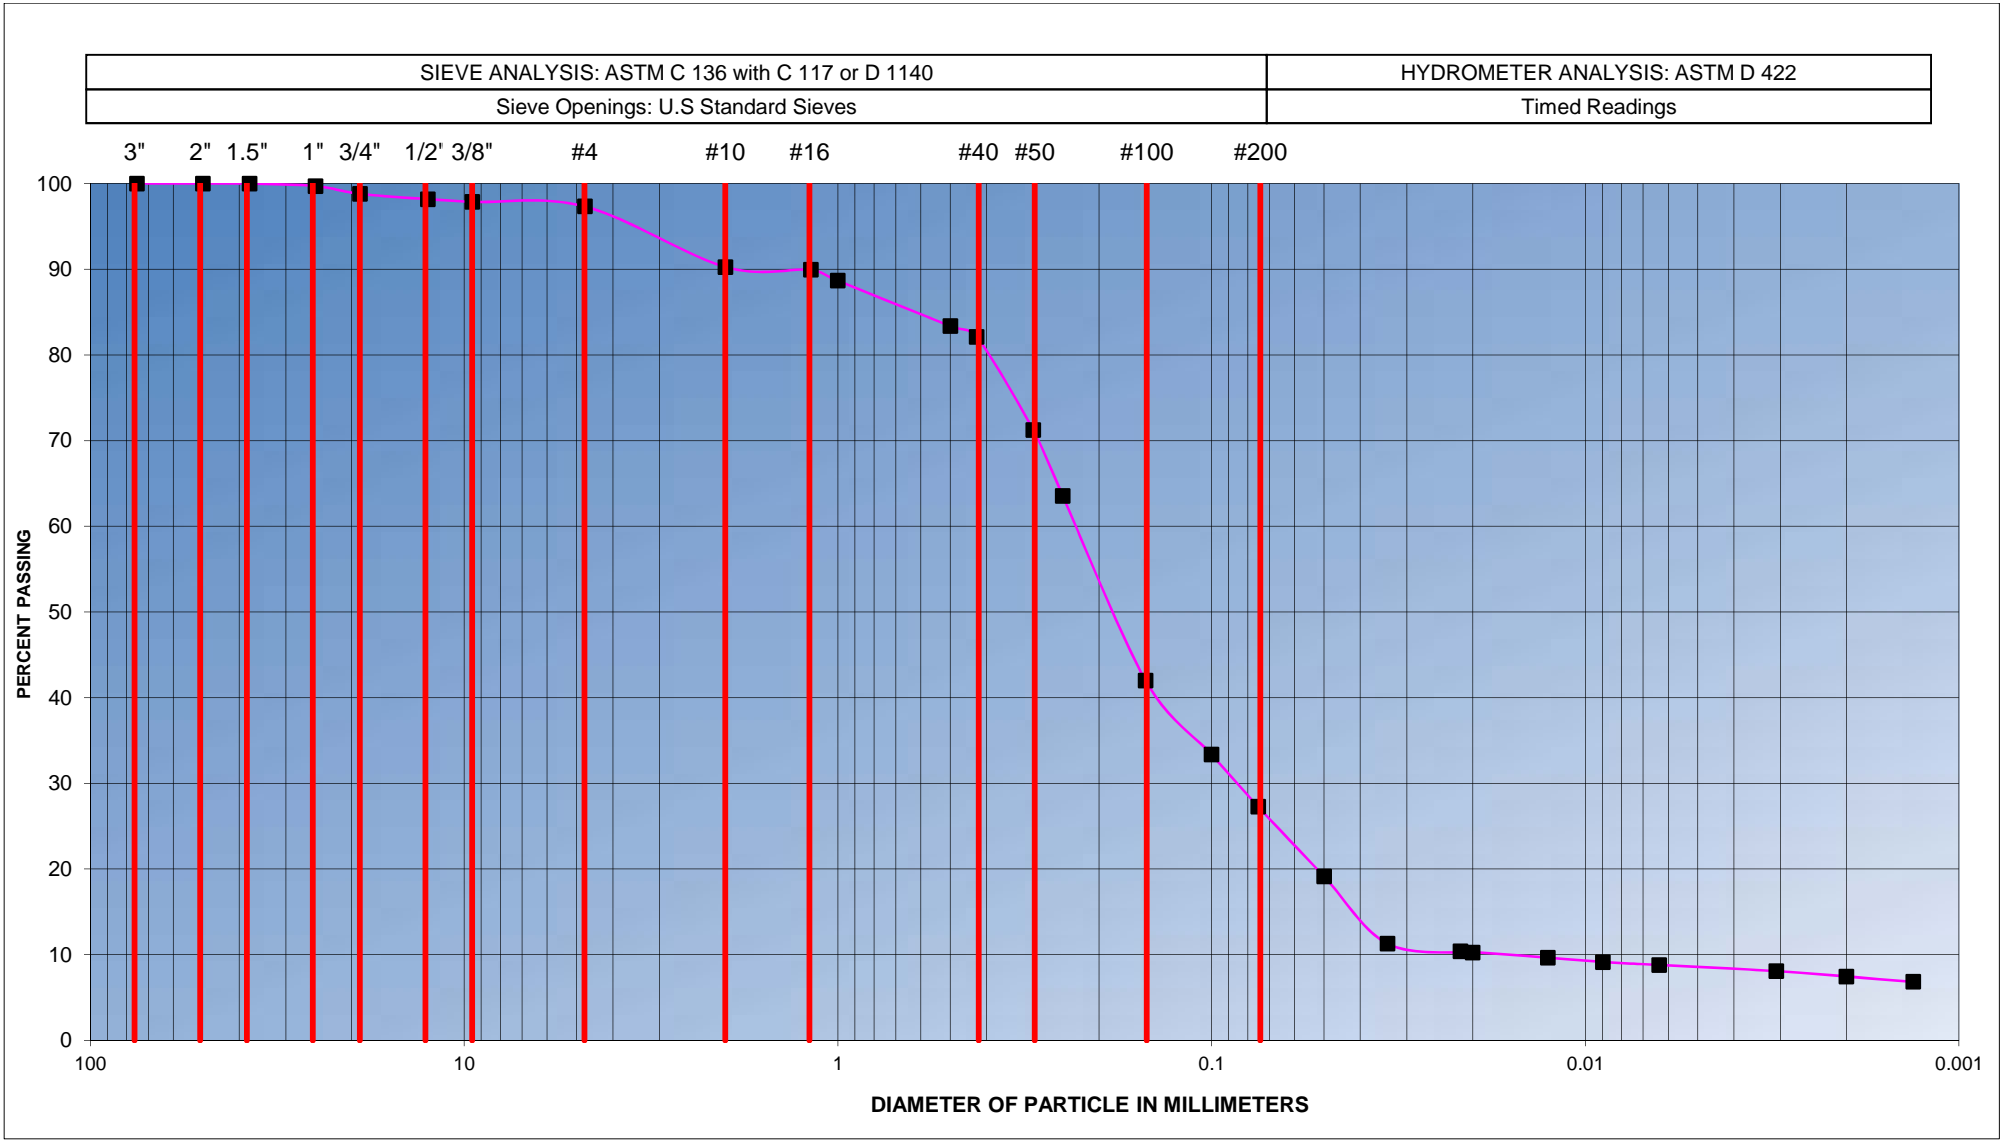
Gravel	3%	Sand	70%	Silt and Clay	27%	<div>GROUND ENGINEERING CONSULTANTS</div>
From: AC-SB-10 15:27 8/24/2016						GRADATION TEST RESULTS	
						JOB NO.: 16-1163	
						FIGURE: 3985

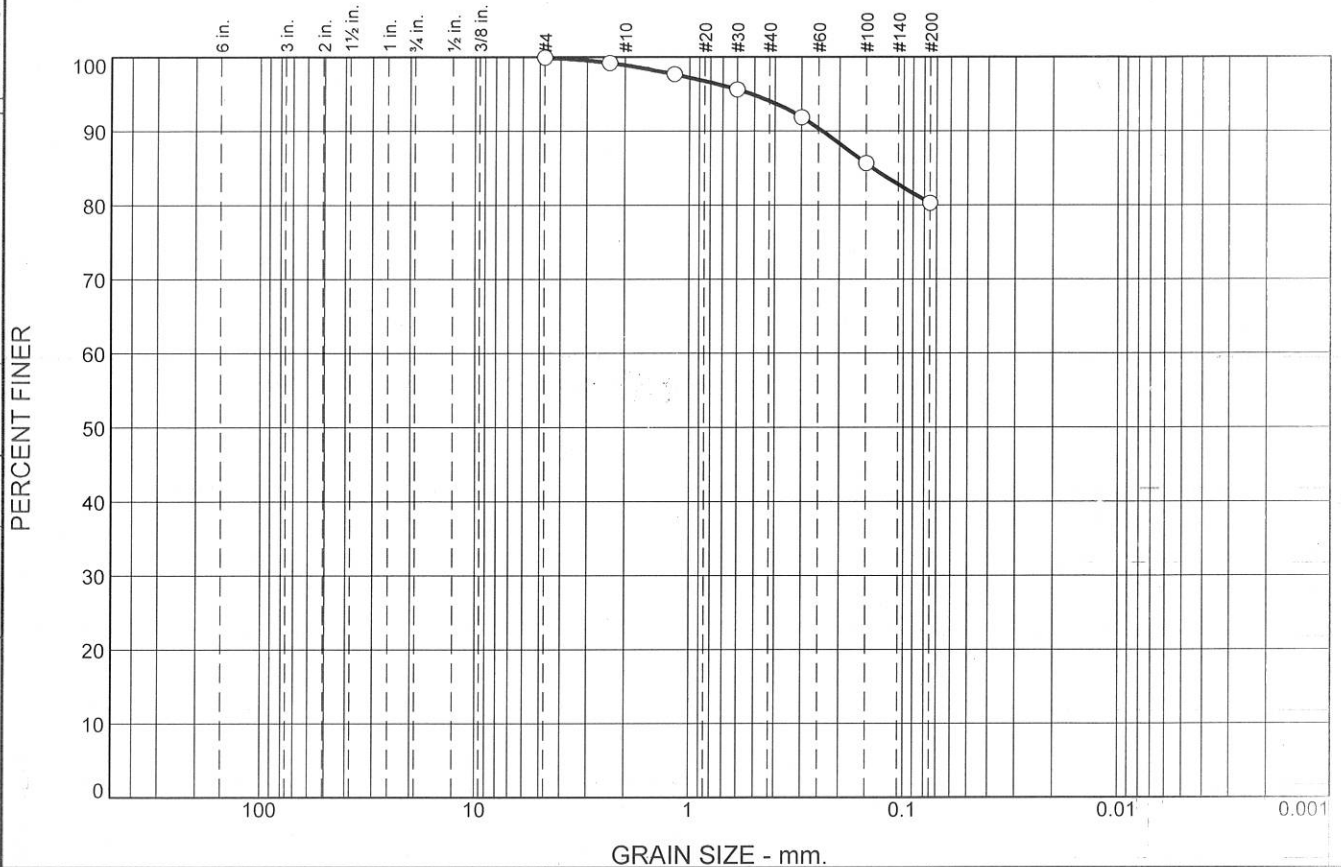
Particle Size Distribution Report

% +3"		% Gravel		% Sand			% Fines	
		Coarse	Fine	Coarse	Medium	Fine	Silt	Clay
				1	5	14	80

SIEVE SIZE	PERCENT FINER	SPEC.* PERCENT	PASS? (X=NO)
#4	100		
#8	99		
#16	98		
#30	96		
#50	92		
#100	86		
#200	80

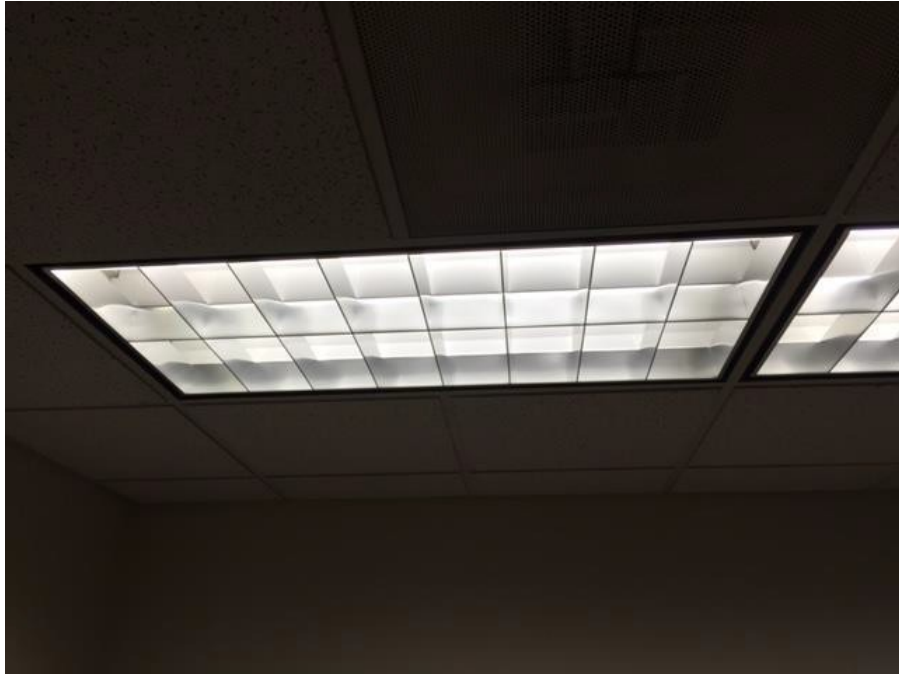
Typical lighting with potential Hg lightbulbs and PCB/DEHP ballasts

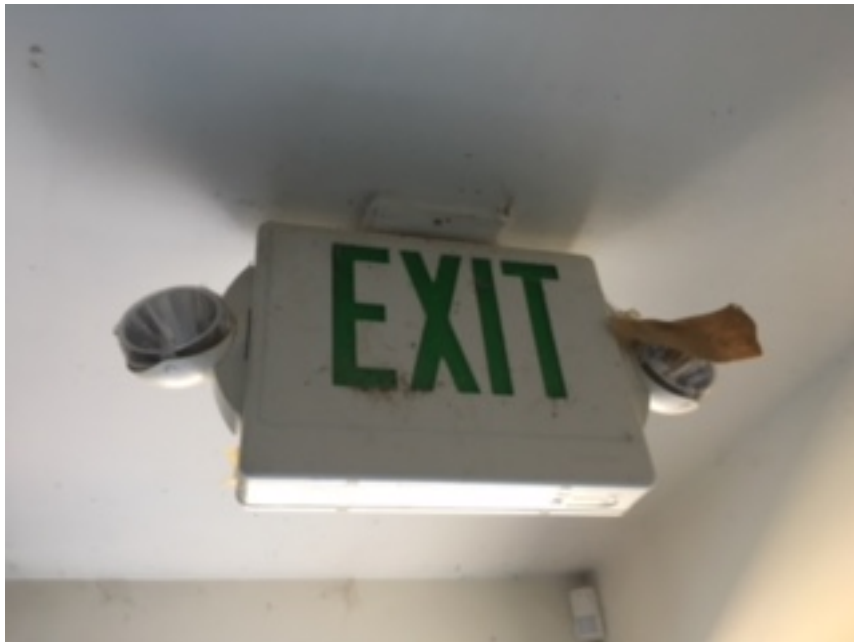
Typical emergency exit sign with potential radioactive isotope

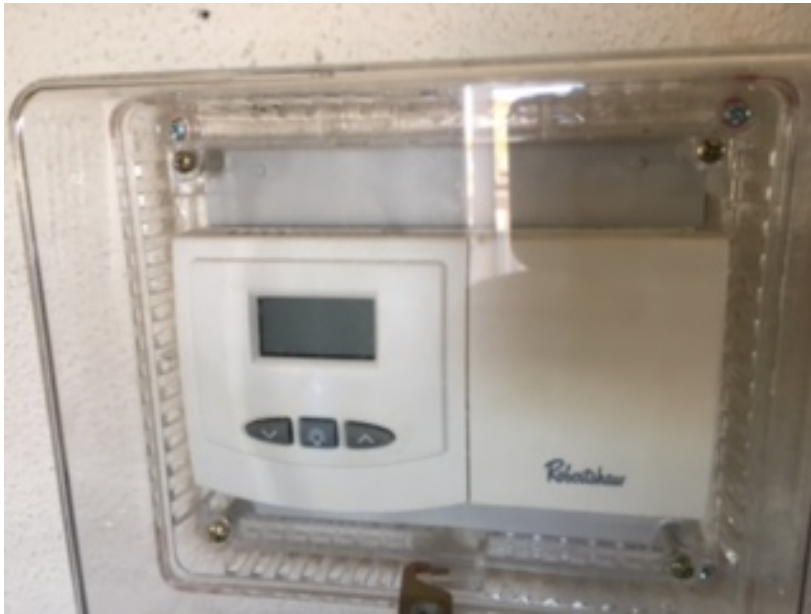
Typical wall-mounted thermostat potentially containing mercury

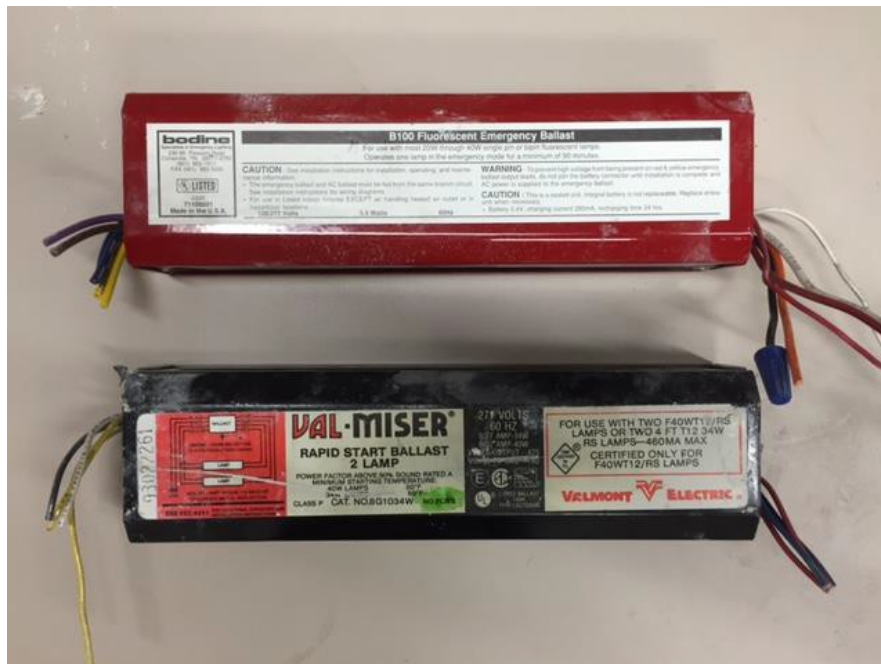
Typical light ballasts with potentially containing PCB or DEHP.

Note - bottom ballast reads “no PCBs” on manufacturer’s label.

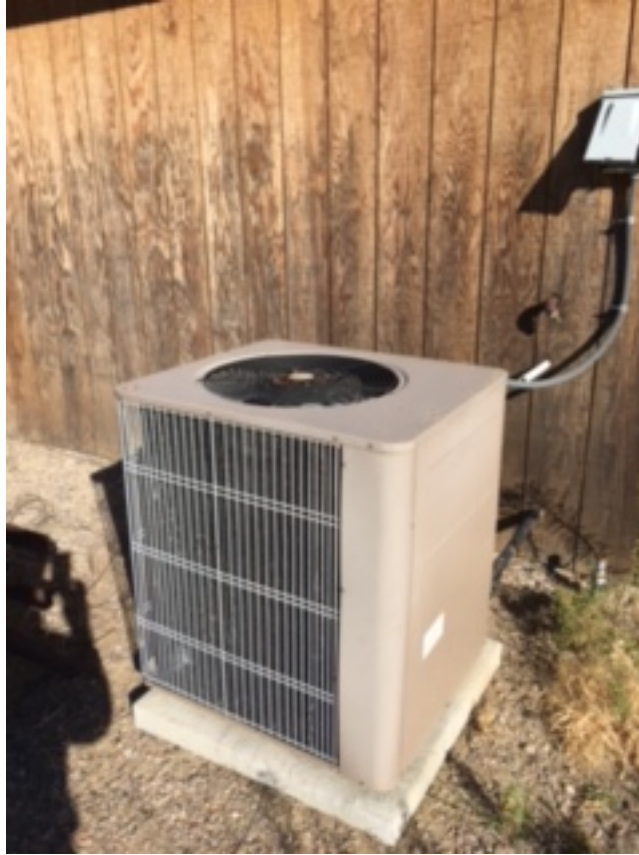
Air conditioning unit with potentially containing Freon

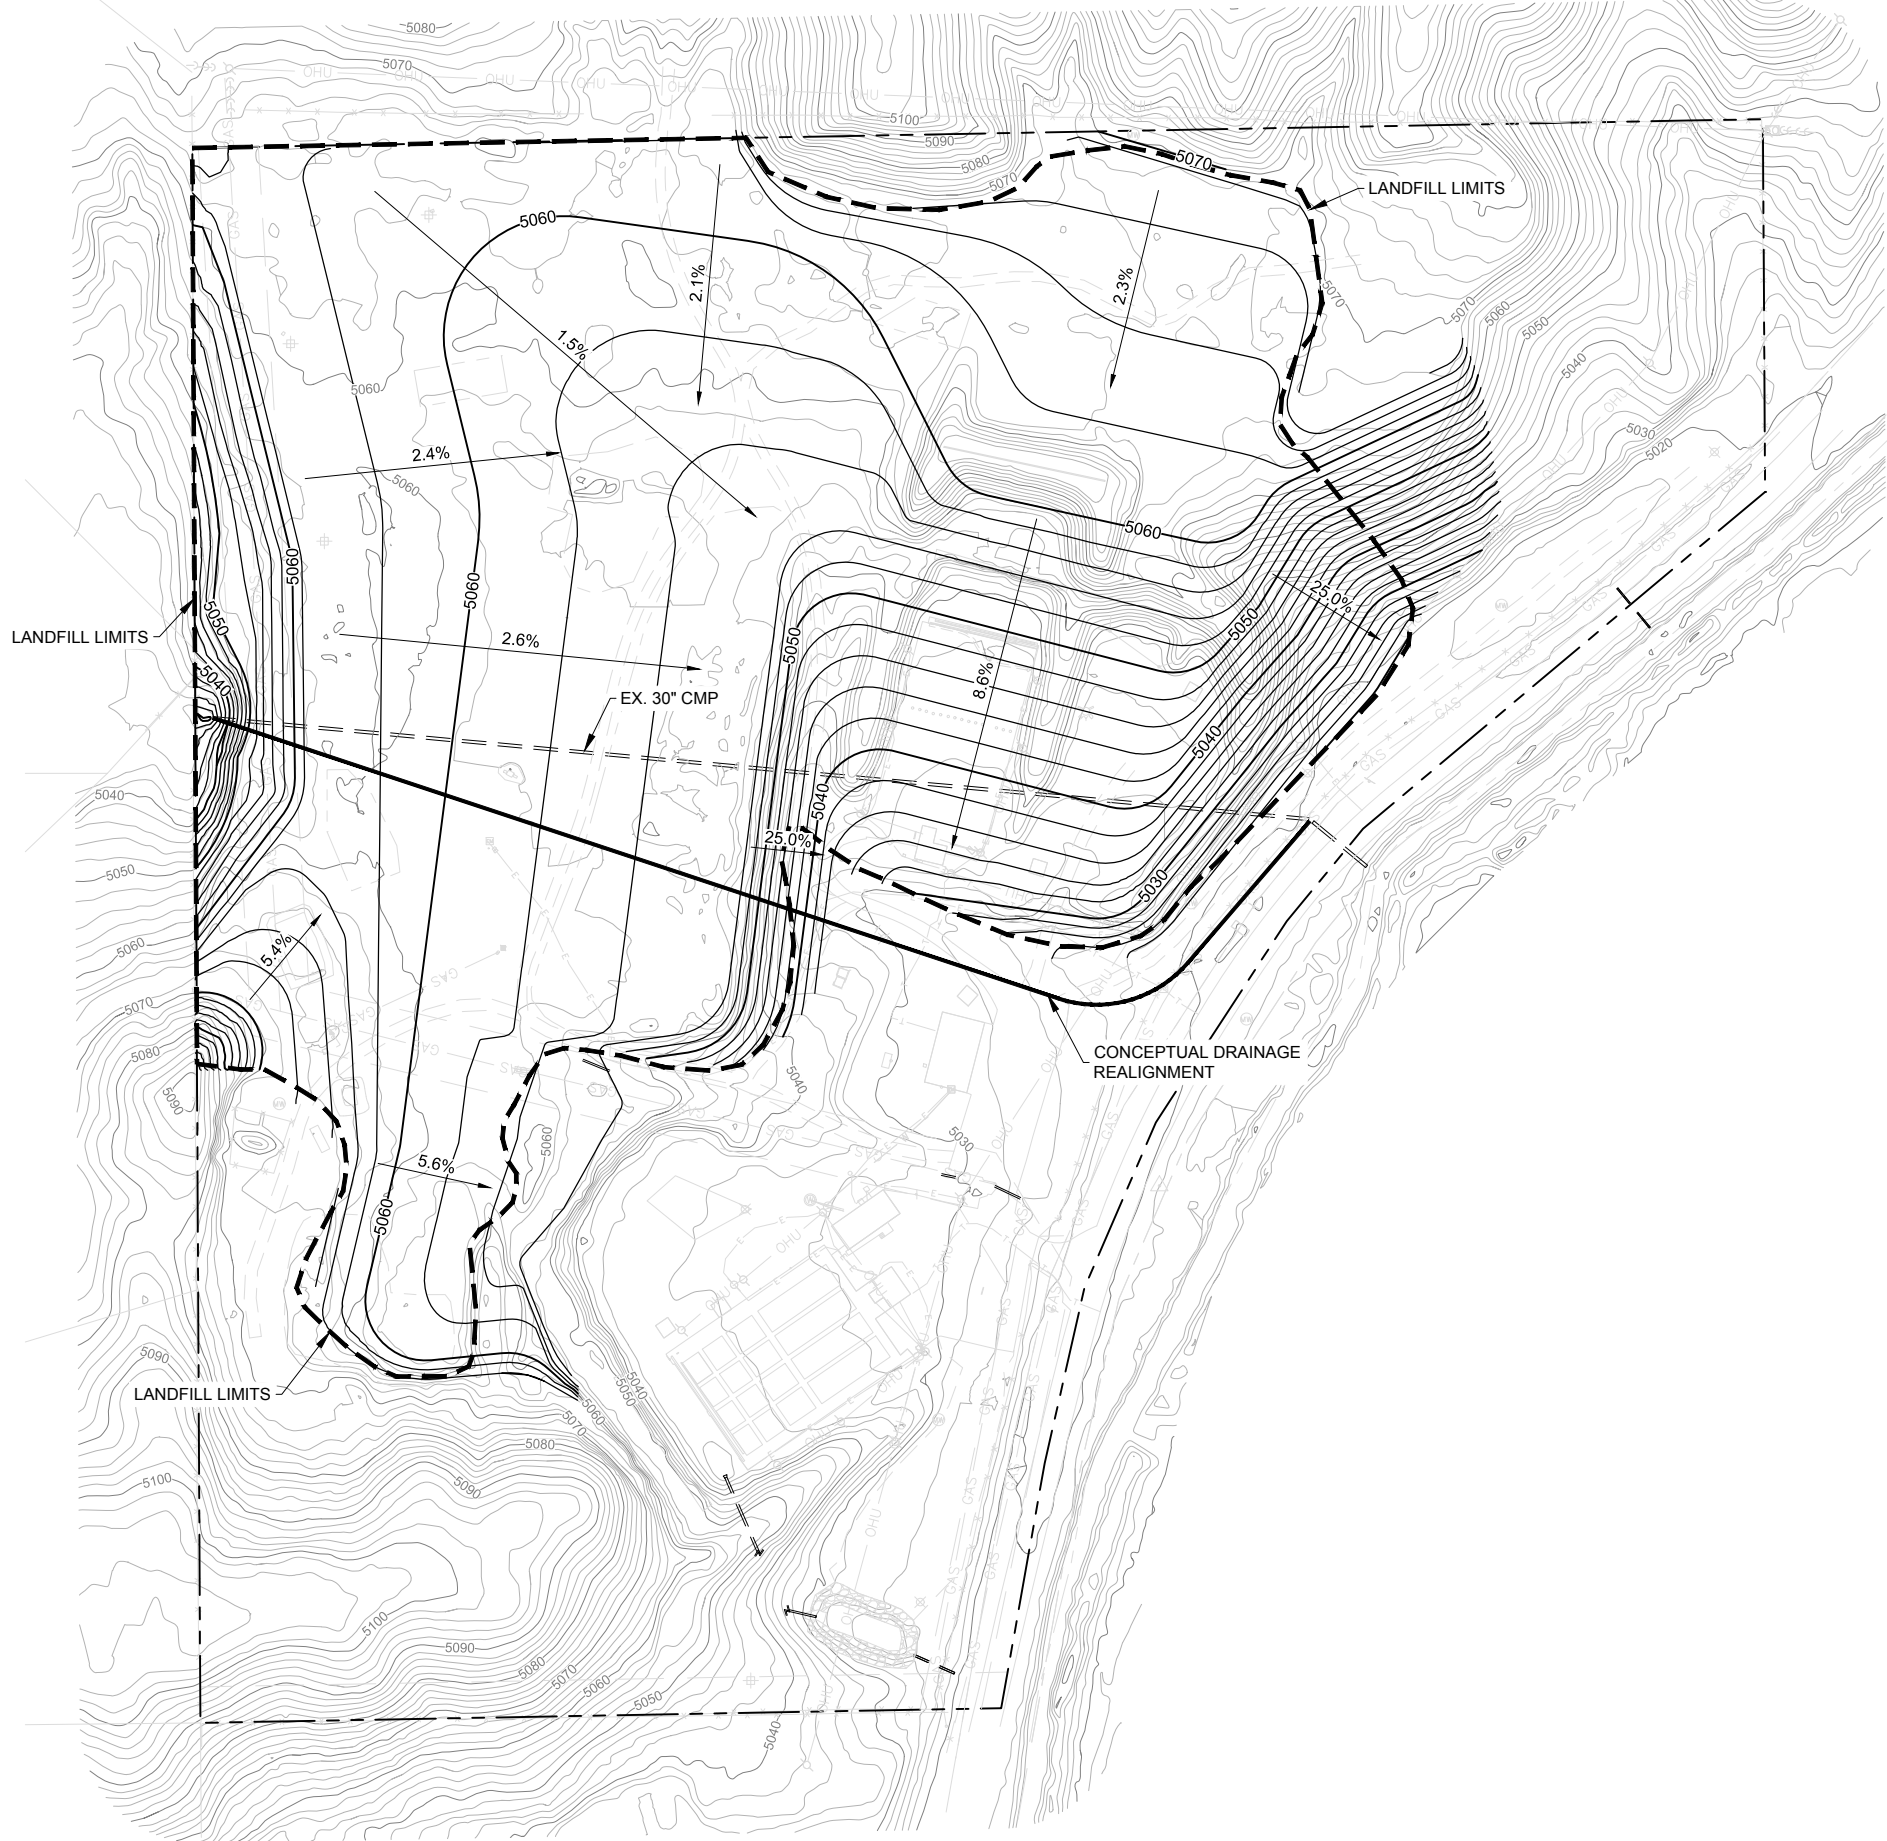
project 90334	contract QUANTUM EC-4
drawing C002	rev. 0
sheet 2 of 3 sheets	file 90334C002GRDF.DWG

- Attachment A – Conceptual Design Drawings. In Attachment A, Drawing C001 shows the existing site conditions as of October 2016, Drawing C002 is the conceptual Gradefill Grading Plan showing the top of waste/bottom of cover design grades, and Drawing C003 shows the conceptual Final Cover Grading Plan and a typical WBC section for the final cover.
- Attachment B – Preliminary List of Technical Specifications
- Attachment C – Preliminary CQA Plan Outline
- Attachment D – Preliminary Budgetary Cost Estimate
